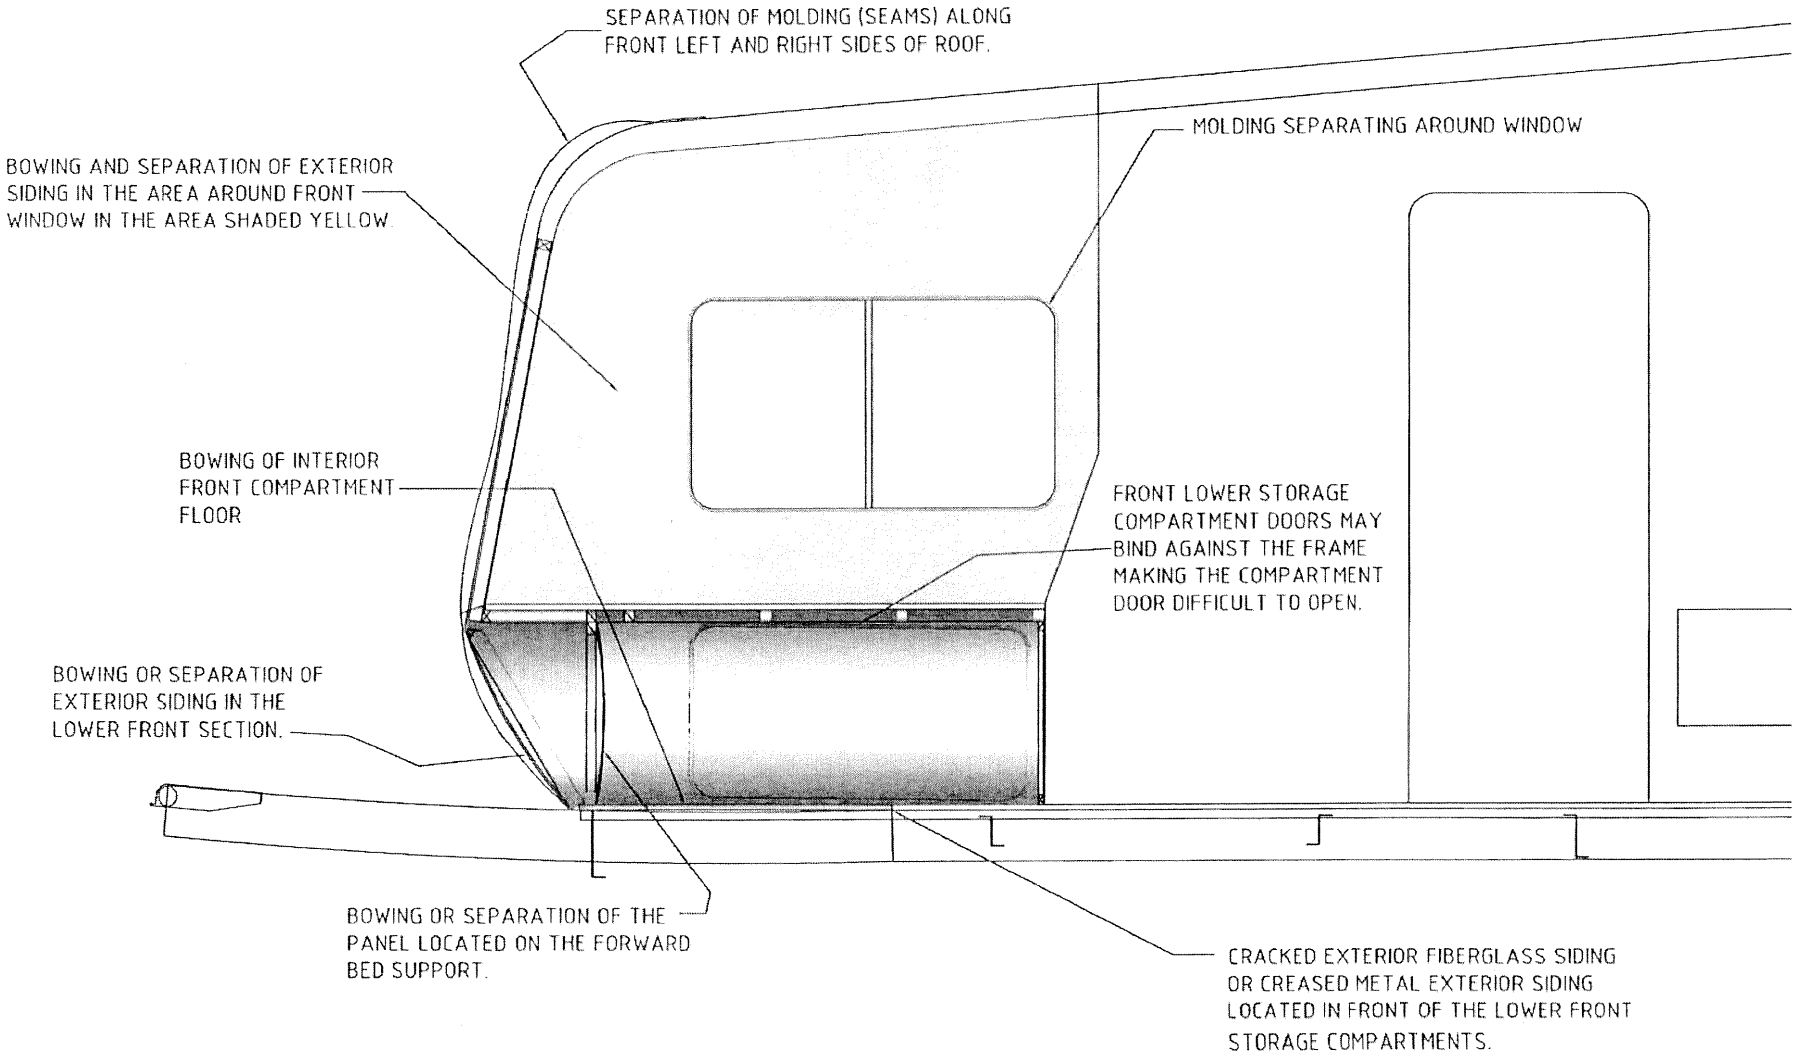
SEPARATION OF MOLDING (SEAMS) ALONG FRONT LEFT AND RIGHT SIDES OF ROOF.
MOLDING SEPARATING AROUND WINDOW
BOWING AND SEPARATION OF EXTERIOR SIDING IN THE AREA AROUND FRONT WINDOW IN THE AREA SHADED YELLOW.
BOWING OF INTERIOR FRONT COMPARTMENT FLOOR
FRONT LOWER STORAGE COMPARTMENT DOORS MAY BIND AGAINST THE FRAME MAKING THE COMPARTMENT DOOR DIFFICULT TO OPEN.
BOWING OR SEPARATION OF EXTERIOR SIDING IN THE LOWER FRONT SECTION.
BOWING OR SEPARATION OF THE PANEL LOCATED ON THE FORWARD BED SUPPORT.
CRACKED EXTERIOR FIBERGLASS SIDING OR CREASED METAL EXTERIOR SIDING LOCATED IN FRONT OF THE LOWER FRONT STORAGE COMPARTMENTS.
